Jordan/Alder Watershed Assessment

February 2006

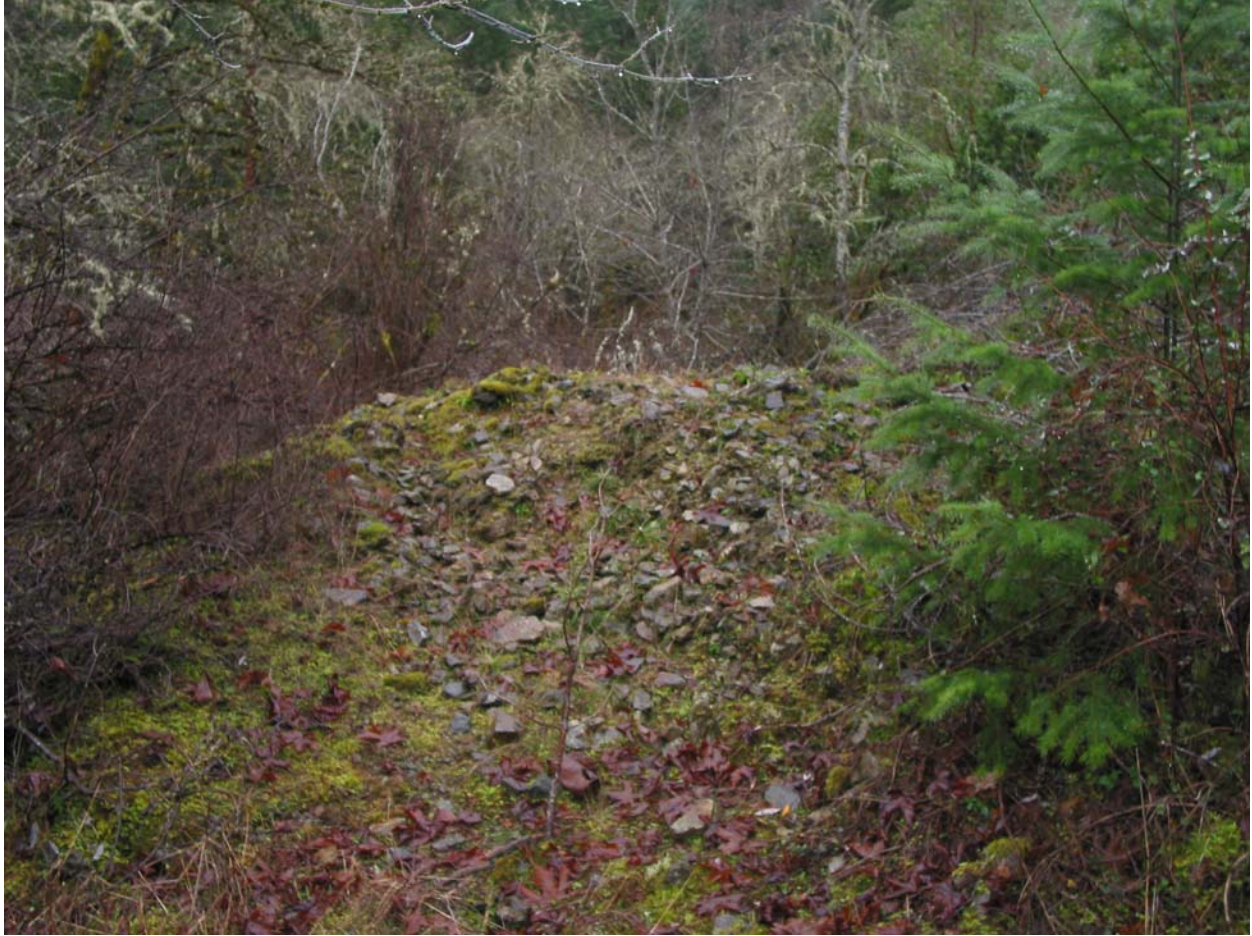
Figure 12. Mine tailings on Jordan Creek south of the Canyonville-Riddle Road.

In addition to the historical falls that serve as a fish passage barrier on upper Jordan Creek (as mentioned above), tailings from mining activity in the early 1900s obstruct fish passage on most of Jordan Creek in the south half of Section 32, T30S, R5W (this portion of Jordan Creek is south of the Canyonville-Riddle Road). Here, Jordan Creek streamflow goes subsurface in places, thus precluding further fish passage.

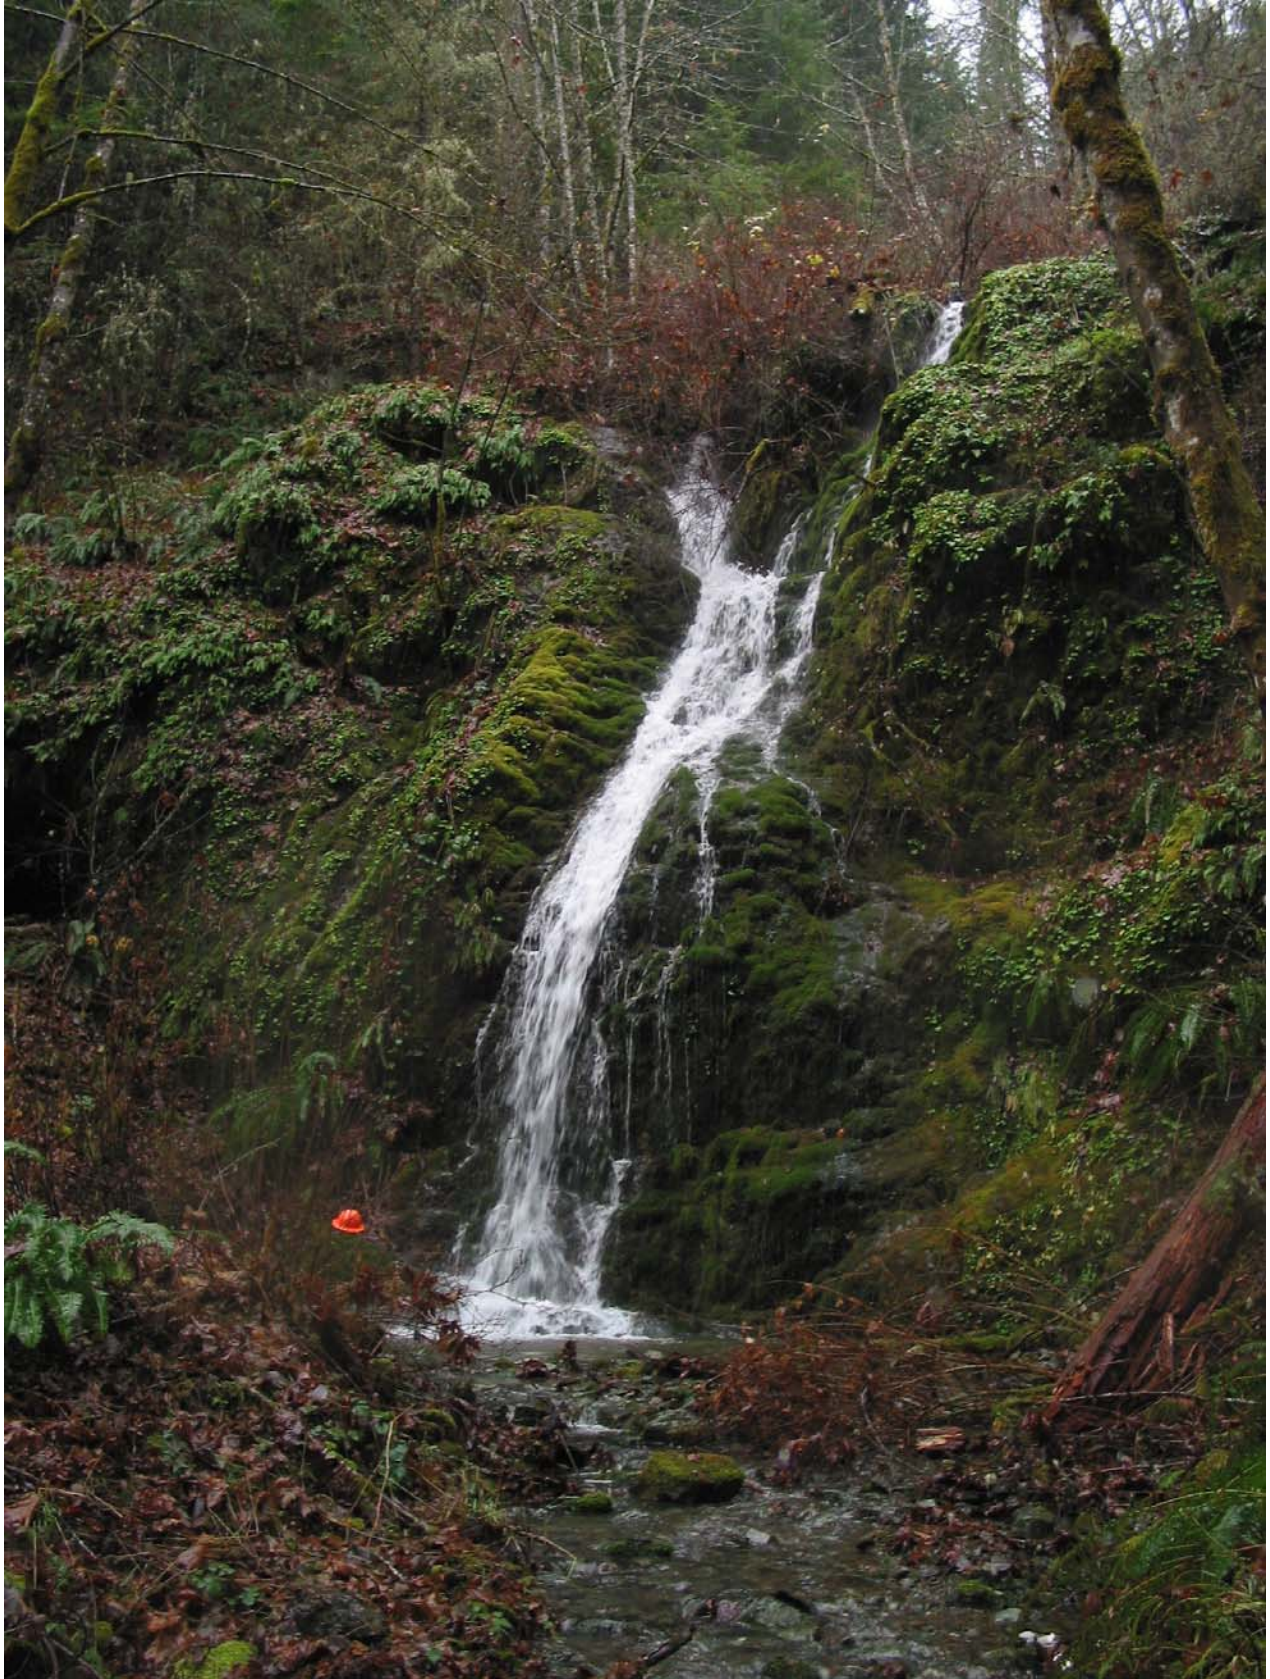
Figure 15. Jordan Creek Falls.

Historically and presently, the falls on Jordan Creek serve as a natural barrier to fish passage. These falls are located near the headwaters of Jordan Creek as shown on Figures 2, 5, and 11. The falls are in two stages: the lower stage is approximately 30 feet in height, while the upper stage is approximately 10 feet in height. Figure 15 shows the falls.

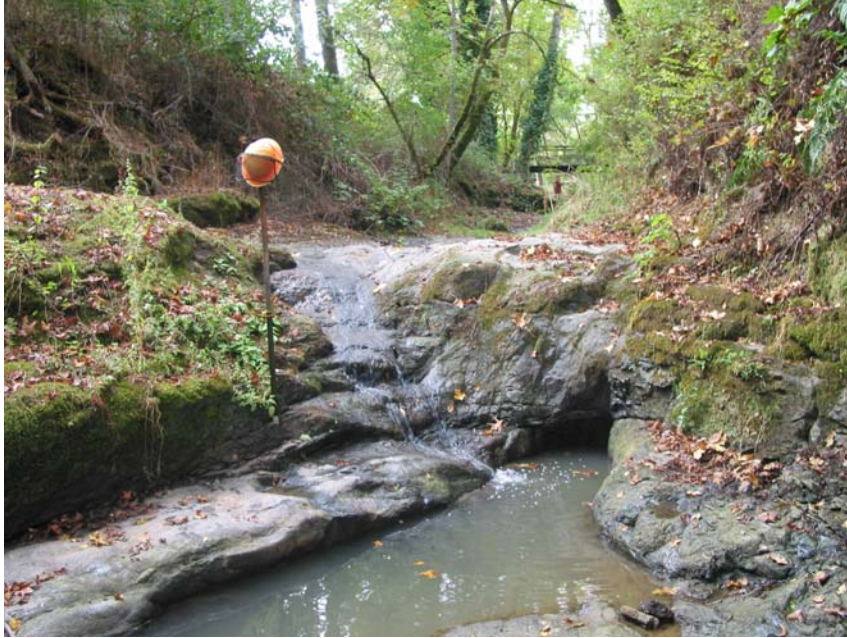
Figure 17. Step upstream of mouth of Jordan Creek on October 6, 2005. Hard hat is resting on top of a six-foot metal fence post. Latitude/longitude: -123.29/42.9443.

While this step may be a barrier to all life stages of fish at low streamflows, adult salmonids are able to pass through this point at higher streamflows (Bill Cannaday, ODFW Habitat Restoration Biologist, personal communication, November 14, 2005). As noted in Section 3.1.2, coho salmon have been observed at the Jordan Creek culvert under I-5, upstream of the step.

Bedrock comprises much of the Jordan Creek substrate below I-5. High streamflows through the I-5 culverts may have washed away gravel and other loose substrate material downstream of the culverts. The strategic placement of large boulders above and below the Jordan Creek step would return “roughness” to this part of the stream channel and facilitate fish passage upstream from the South Umpqua River.

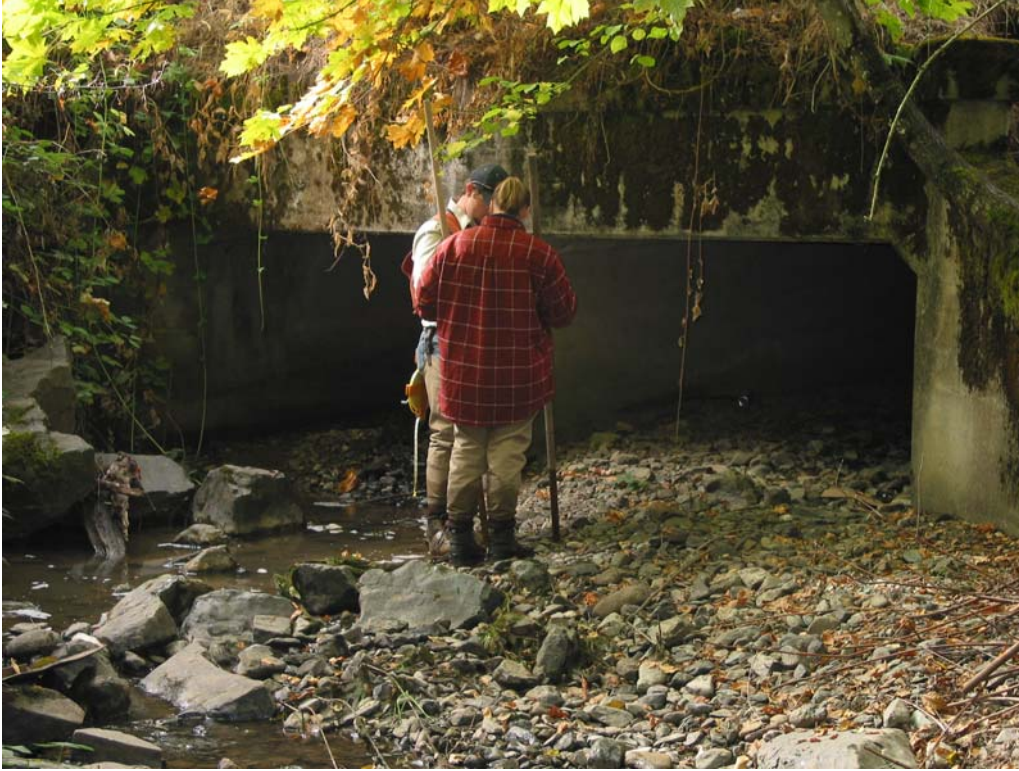
Figure 21. Culvert #1 outlet on Jordan Creek at I-5.

All of these culverts, except for culvert #7, are within ODFW's potential habitat range for coho salmon and winter steelhead as identified in Figures 13 and 14. The most limiting for fish passage of all culverts in the Jordan/Alder Watershed are the twin culverts through which Jordan Creek passes underneath I-5 and the frontage roads on either side of I-5, noted as culvert #1 in Figure 20 and Table 8. Here, Jordan Creek passes through twin reinforced concrete box culverts, each of which is approximately 360 feet in length. These culverts act as barriers because of the high streamflow velocity as water flows through these concrete "chutes." The lack of light within the culverts may also serve as a barrier to fish passage.

There are ongoing discussions between the Tribe, Oregon Department of Transportation, and others regarding a fix for the I-5 culvert. Possible solutions include a replacement bridge, weirs or baffles inside the existing culverts to decrease stream velocity, skylights to provide natural light, and/or artificial lighting inside the culverts.

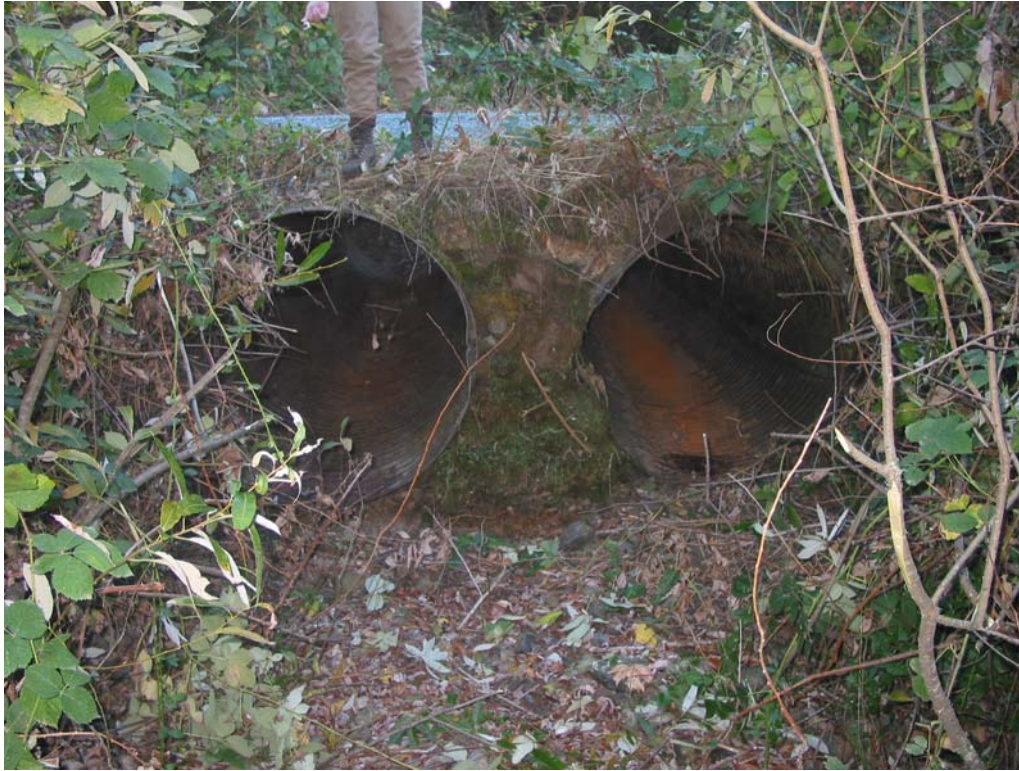
Figure 23. Culvert #2 outlet on Jordan Creek at north end of Rod & Gun Club Road.

Four other culverts (culverts #1, 2, 6, and 11) are currently failing. One of the two corrugated metal pipes at culvert #2 is being flattened vertically. There is a “ram” inside this culvert to prevent it from collapsing. Anecdotal evidence suggests that this culvert began to fail during the 1996 high streamflow events. Culverts #6 and 11, also corrugated metal pipes, are rusting out and failing at their bottoms.

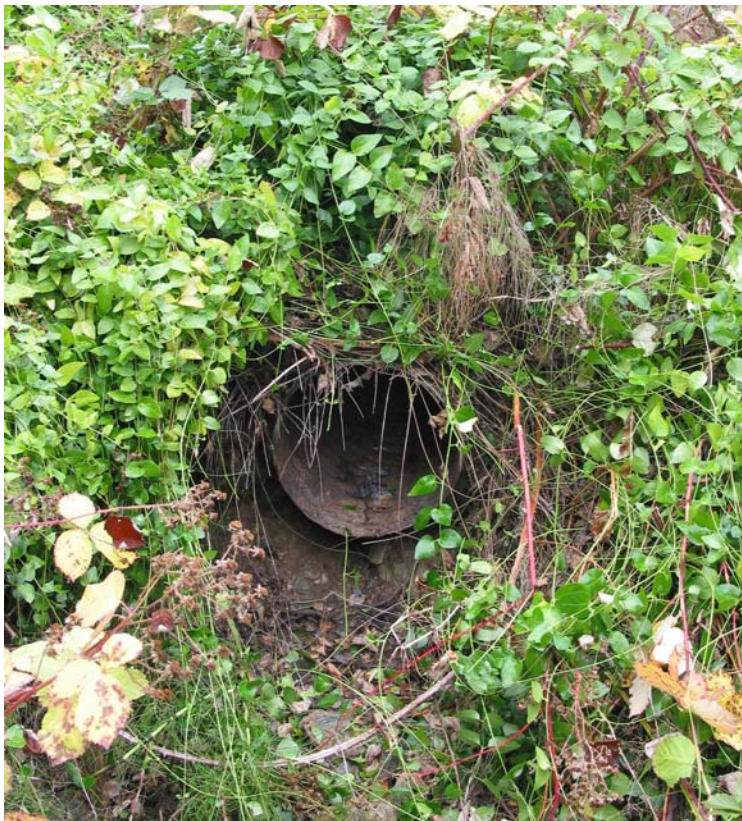
Figure 26. Culvert #4 outlet on Jordan Creek at washed-out road off Rod & Gun Club Road.

Culvert Physical Condition. Two of the 12 culverts (culverts #4 and 8) failed at some time in the past. These culverts may have failed during the high streamflows of the 1996 storm events. These two failed culverts are now only partially functional, with at least some of the water flowing around rather than through the culverts. Note that the two failed culverts have the lowest flow capacity relative to the 50-year and 100-year storm events. The original size of culvert #4 would allow it to carry 3% of a 50-year storm event and 2% of a 100-year event. Culvert #8 was sized to carry 17% and 12% of a 50-year and 100-year storm event, respectively. These culverts no longer serve the purpose of allowing for a road crossing of the streams.

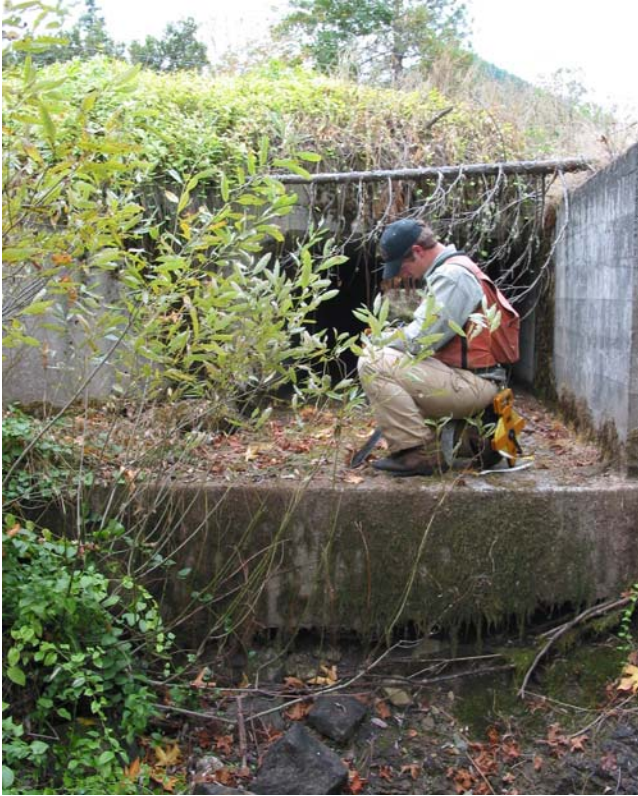
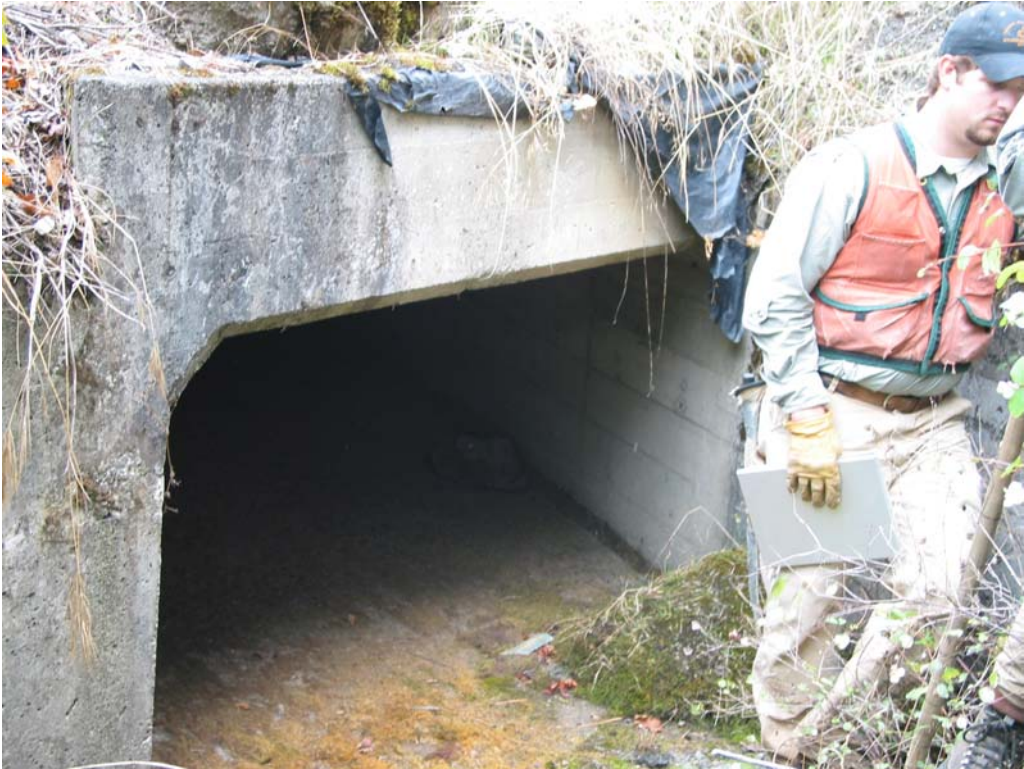
Figure 29. Culvert #7 outlet on Jordan Creek at Canyonville-Riddle Road.

Figure 30. Culvert #7 outlet on Jordan Creek at Canyonville-Riddle Road.

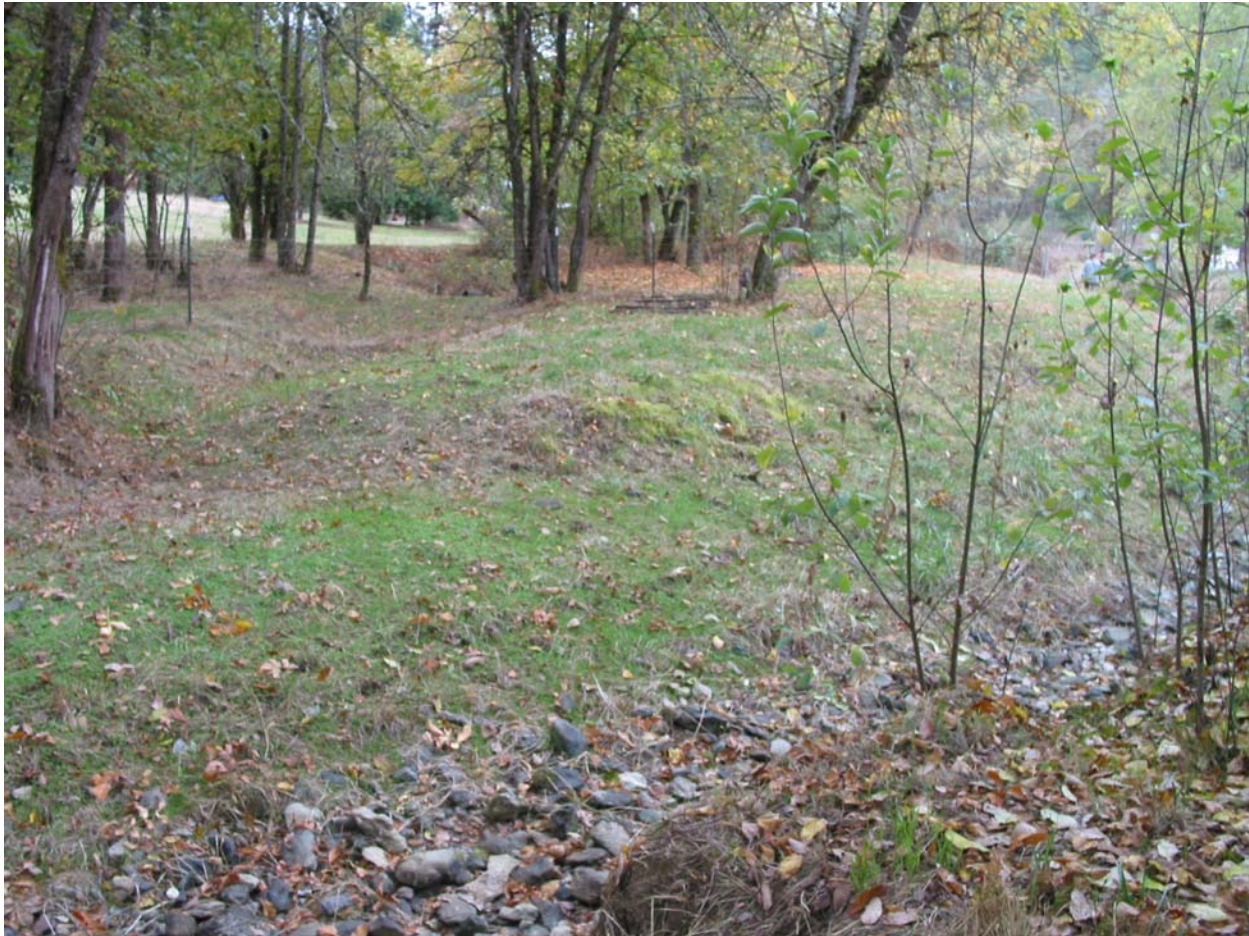
Figure 36. Jordan Creek showing evidence of historical channel (left) and current channel (right, with gravel in channel). Latitude = -123.304°, longitude = 42.9271°.

Evidence suggests that Jordan Creek has been modified since settlement times in order to develop and extract resources from the watershed. Miners searching for gold and silver in Jordan Creek in the 1860s re-routed the creek in order to facilitate mineral exploration in the original channel. There is direct evidence of this re-routing in Tax Lot 1100, Section 28, T30S, R5W (the Nunes property). Here, the riparian area along the “new” channel is free of vegetation for some stretches while vegetated with blackberries and annual plants in others. The “old” channel has a narrow, forested riparian area. Figure 36 below shows both channels. In this image, the direction of streamflow is from the background to the foreground.

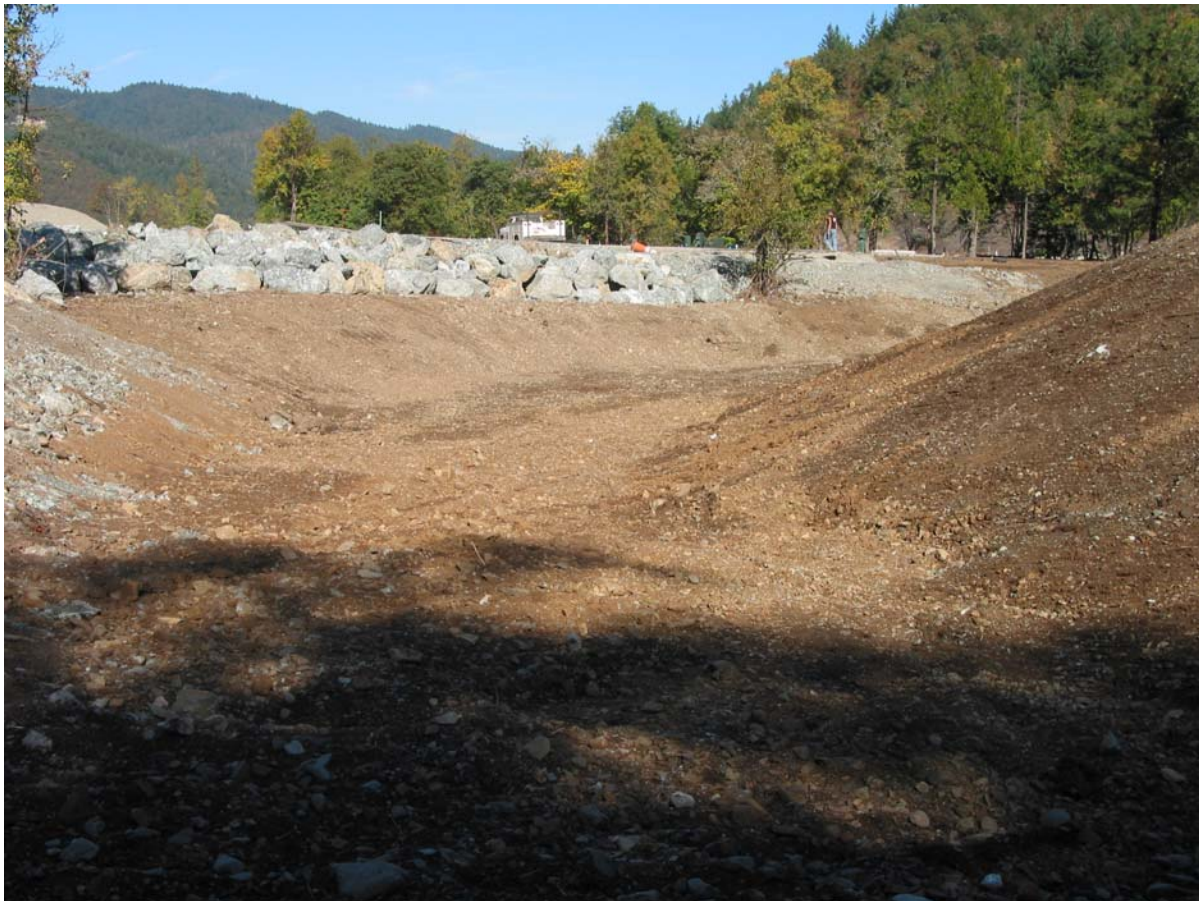
Figure 37. Jordan Creek channel below upper bridge on October 6, 2005.

Current RV park development along lower Jordan Creek has also simplified Jordan Creek's channel by removing vegetation and, perhaps, in-channel woody debris. Figure 37 shows a stretch of lower Jordan Creek (upper end of reach 1) just below the upper bridge in the RV park. This is by far the most notable case of channel disturbance in the RV park area. But, the extent of simplification of this reach of Jordan Creek relative to its condition prior to the RV park development is unclear.

It should be noted that, while this riparian disturbance may be significant in the short term, it is anticipated that there will be long-term benefits from the removal of riparian blackberries and other shrubs less desirable from a riparian vegetation standpoint. Also, the RV park development has included the removal of tires, batteries, and other debris from Jordan Creek left over from truck stop operations prior to those of the current Seven Feathers Truck and Travel Center (Jeff Byers, Creekside RV Park Project Manager, personal communication, August 5, 2005).

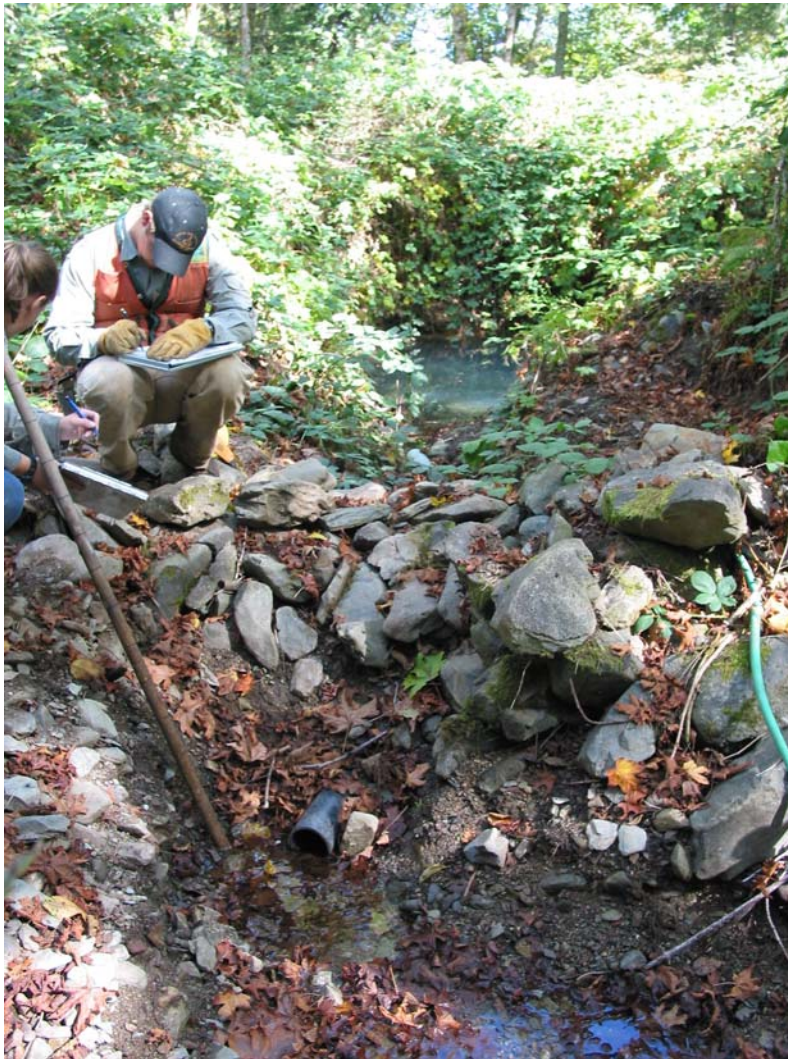
Figure 38. Water diversion on Alder Creek.

Figure 38 shows what is likely the most significant of the water diversion channel modifications. This diversion is located on Alder Creek. In the figure, Alder Creek runs perpendicular to the short piece of black plastic pipe shown in the bottom middle of the photograph. The gravel diversion structure, routing water through the black plastic pipe, is shown in the bottom left of the photograph, to the left of the wooden staff pole.

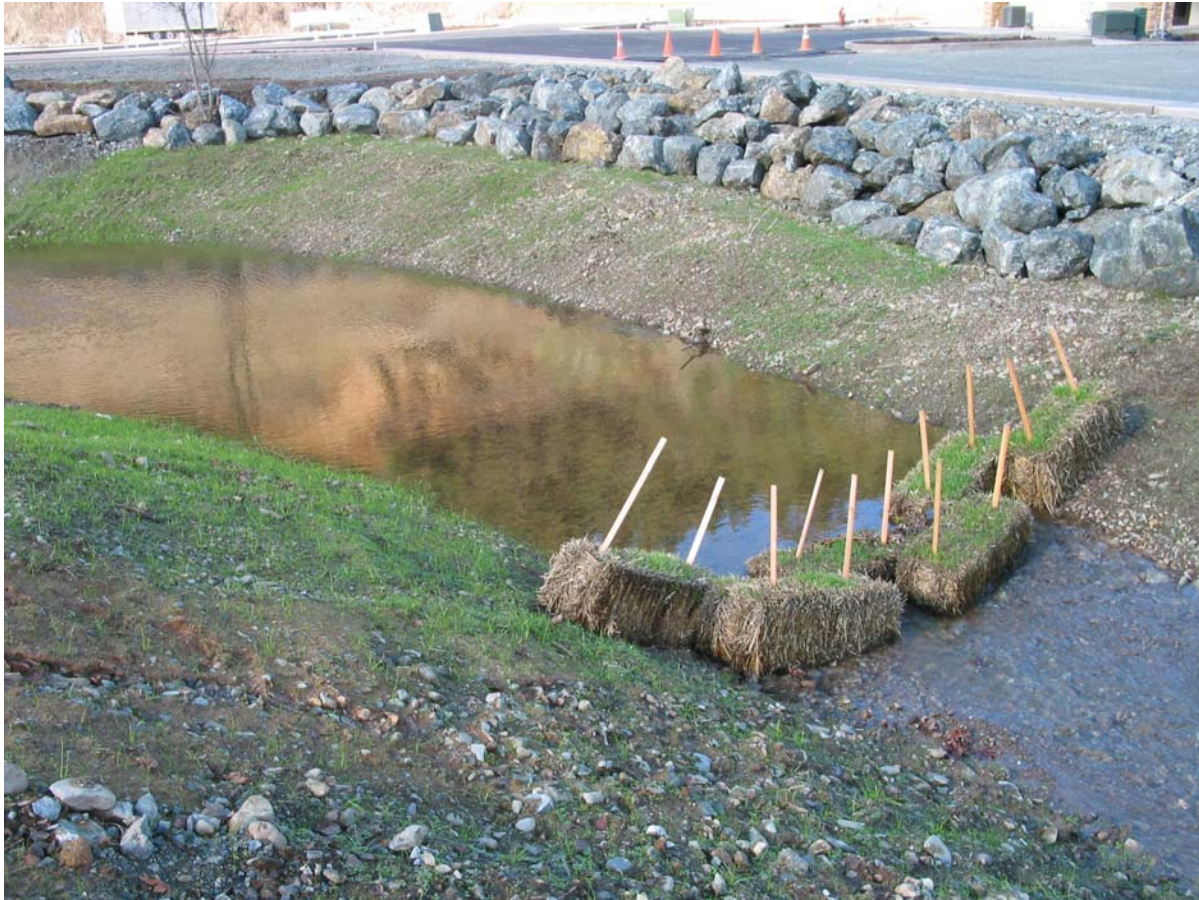
Figure 39. Jordan Creek on November 14, 2005, looking upstream toward upper bridge in Creekside RV Park.

6. Place large woody debris in the lower half of Jordan Creek Reach 1 specifically to capture gravels to improve spawning habitat and add roughness to the stream channel. Note the pooling effect and the beginning of spawning habitat riffle creation taking place in Jordan Creek Reach 1 below bridge #3 in the Creekside RV Park as shown in Figure 39 below. For comparison, Figure 37 shows the same stream stretch six weeks earlier, prior to the onset of fall rains.

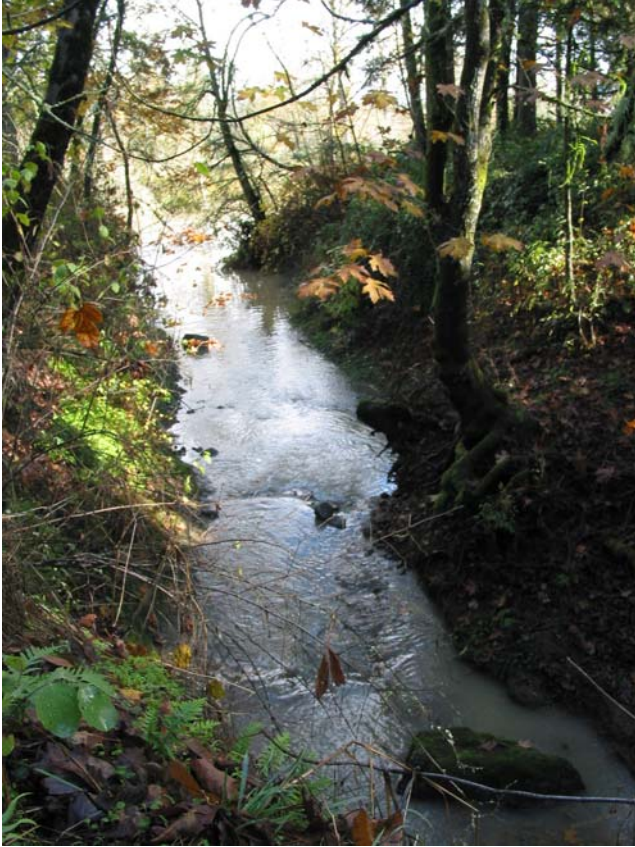
Figure 41. Mouth of Jordan Creek on November 14, 2005.

The final 150 feet (approximate) of Jordan Creek fills with backwater from the South Umpqua River up to the step noted in Section 3.2.1. This “pool” of water, as shown on November 14, 2005, in Figure 41, serves as a very important resting refuge for salmonids, especially during heavy streamflows in the South Umpqua River. The retention and, where needed, establishment of riparian vegetation along both sides of this pool is critical.

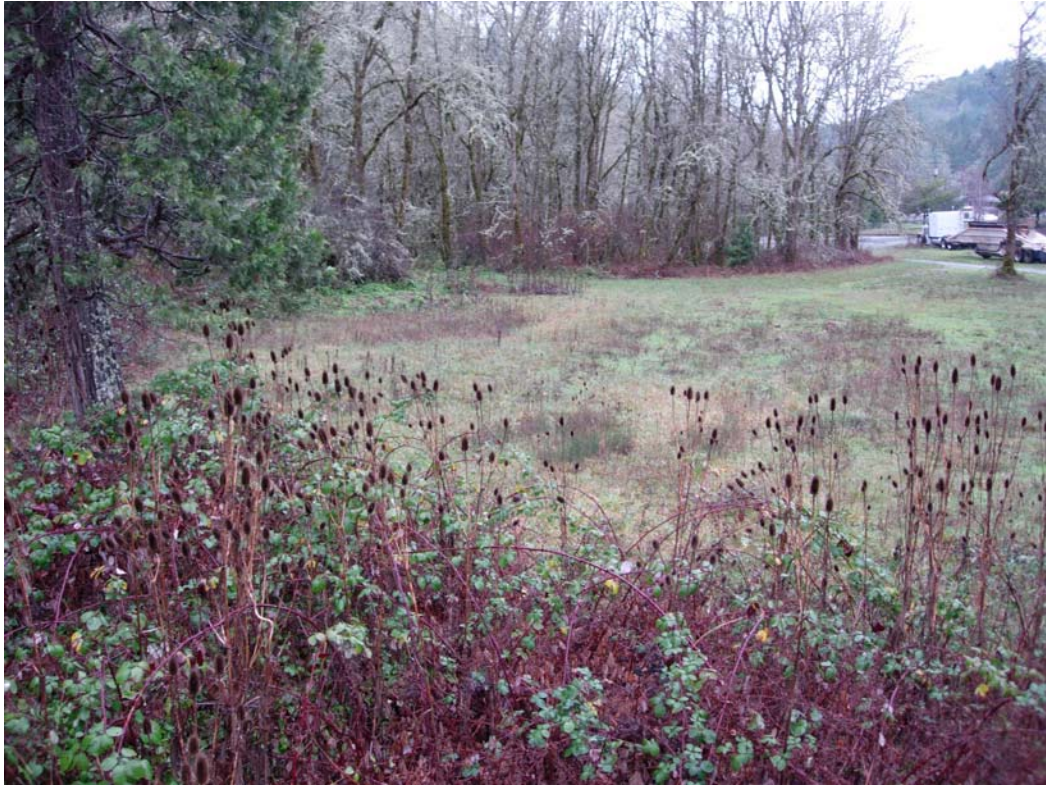
Figure 44. Current parking area/potential wetlands at Rod & Gun Club.

The current Rod & Gun Club property contains a potential wetland (which is, perhaps, an historical wetland). This “wetland” is located near culvert #2, where Jordan Creek passes under the Rod & Gun Club Road. Here, there are new wetlands possibilities on both sides of the Rod & Gun Club Road. See Figure 43 for the location of the potential wetlands and other identifying features discussed in this section. Figures 44 and 45 are images of this potential wetlands site.

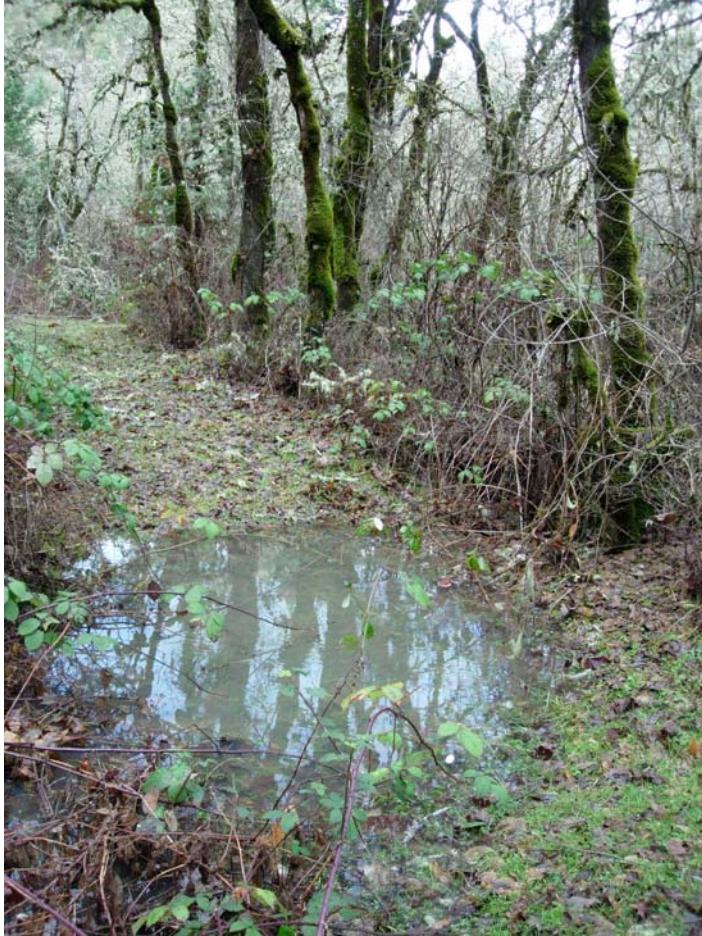
Figure 47. Alder Creek side channel and pool development opportunity.

1. The Alder Creek side channel appears to be a secondary channel, or perhaps what was once Alder Creek’s primary channel. Though this channel is likely dry during the summer months, it does carry water and maintains an attachment to the current primary Alder Creek channel during the winter months. It may be possible to develop an off-channel pool in this side channel for use as rearing and over-wintering habitat. Wetlands development may be possible adjacent to this side channel and pool. Figure 47 shows a small pool already developed in the side channel.

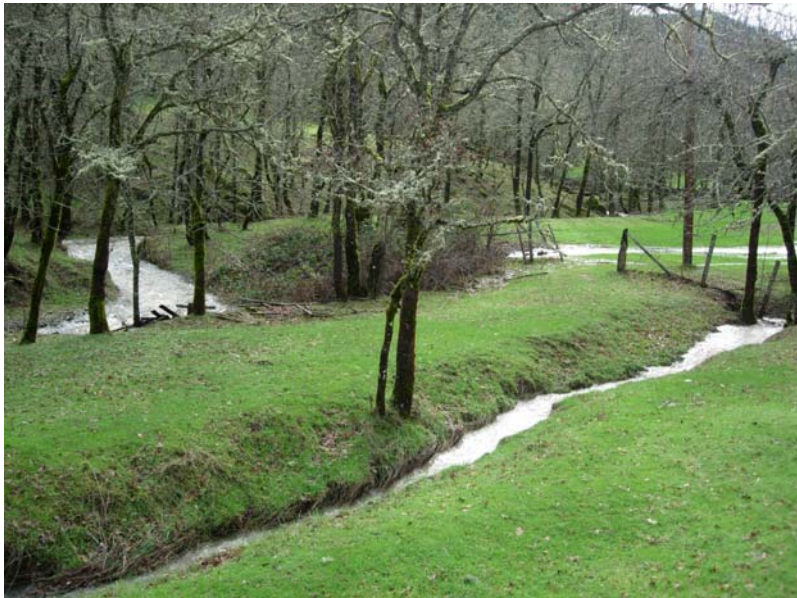
Figure 48. “Nunes” rearing pool development opportunity (background right) and augmentation stream (foreground), with Jordan Creek on left.

2. The “Nunes” rearing pool area near Jordan Creek provides an opportunity to develop an off-channel pool for rearing and over-wintering habitat. This pool area is currently an inactive pasture that captures water from road runoff and excess streamflow from an adjacent tributary to Jordan Creek. Any rearing pool created in this area could be fed by water from the Creekside RV Park’s upper reservoir. Streamflows in Jordan Creek itself could also be augmented by water from the upper reservoir via this same tributary. It may be possible to develop wetlands around this pool. Figure 48 shows the potential rearing pool site as well as the augmentation stream.

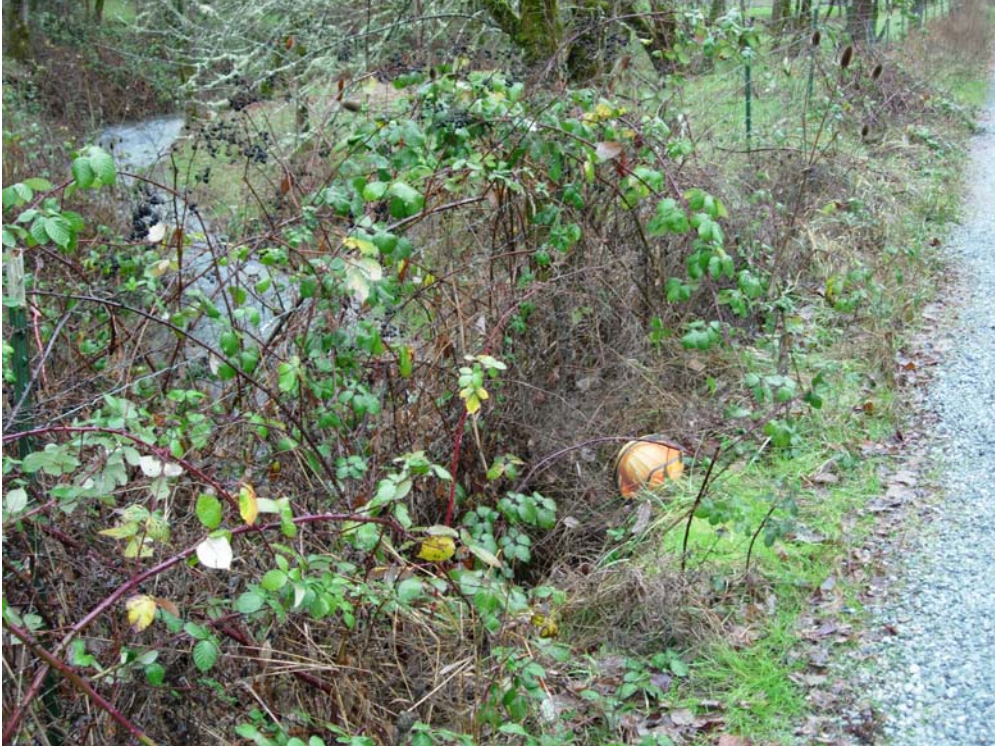
Figure 54. Rod & Gun Club Road adjacent to Jordan Creek.

Rural Road Runoff. The earlier section on “Road Instability” addresses the potential sediment delivery from roads near streams. Much of the Rod & Gun Club Road is within 70 feet of Jordan Creek (see Figure 51). There are several locations along this road where the road is located at the top of a steep streambank along the creek. Figure 54 shows one such location near Tax Lot 1100, Section 28, T30S, R5W (the Nunes property). During past periods of high streamflows, the creek has eroded away the road, creating sediment immediately input to Jordan Creek.

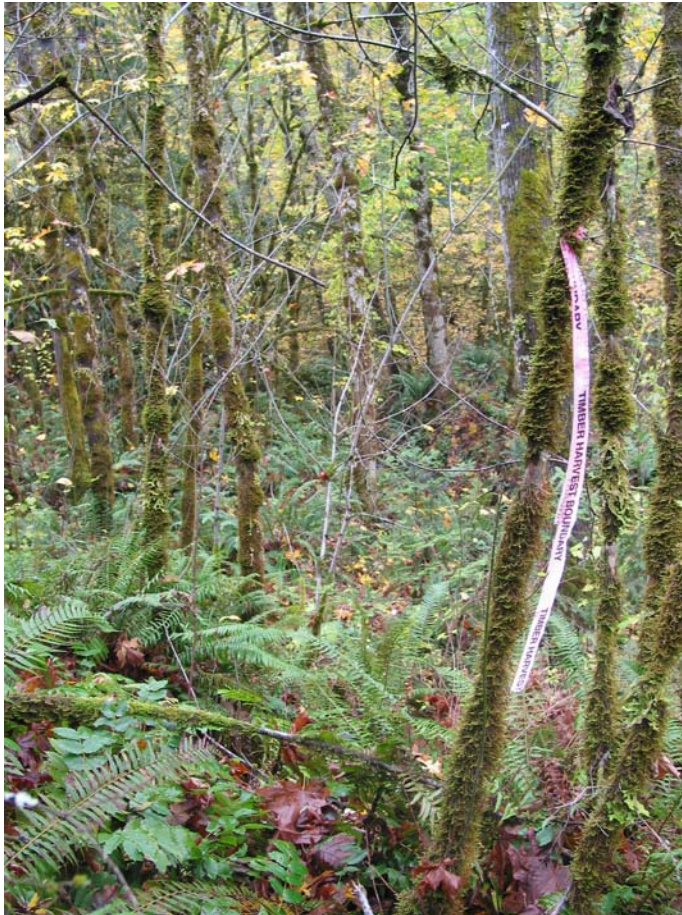
Figure 56. Alder Creek riparian management area after adjacent timber harvest.

The FPA requires protection of streams and riparian areas during road construction, timber harvest, and other forest operations. RMA rules, including zones of protected vegetation and other requirements, require protection on fish-bearing, domestic use, and some other streams. Figure 56 shows an RMA on Alder Creek after an adjacent clearcut harvest.
